NASA/TM-2008-215100
NESC-RP-06-115/06-028-E

International Space Station (ISS) S-Band Corona Discharge Anomaly Consultation

NASA Engineering and Safety Center Technical Consultation Report	Document #: RP-06-115	Version: 1.0
Title: ISS S-Band Corona Discharge Anomaly Consultation			Page #: 1 of 26

December 14, 2006

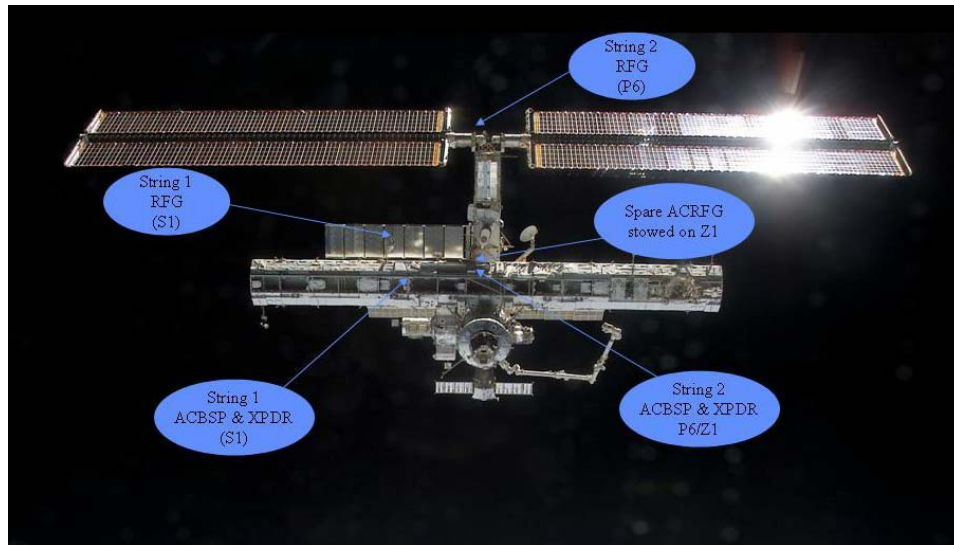
Figure 6.1-2. ISS S-Band Installation Sites

On April 13, 2006, there was a reflected RF power anomaly observed after four minutes nominal operation within the ACRFG (refer to Figure 6.1-1). This was in the “String 1 RFG” unit on S1 (S/N 002) as shown on the ISS in Figure 6.1-2. The “String 2 RFG” unit (S/N 003) on P6 is the primary unit. The spare unit (S/N 001) is stowed on Z1. Corona was examined as a possible root cause of the anomaly. Section 3.5 of the MDA ACRFG Reflected RF Power Anomaly Report (ref. 1) determined the necessary voltages to produce corona, at various pressures, in the narrowest electrode gaps in the coaxial cavity 5-pole diplexer and 3-pole bandpass filter (see Figure 6.1-3) assemblies. The results of the MDA analysis suggest the conditions present in the Bandpass Filter and Diplexer at 1 psia may have been favorable for the corona.
